Inspected Equipment:

**Swichfuse**

# Dist Board KP

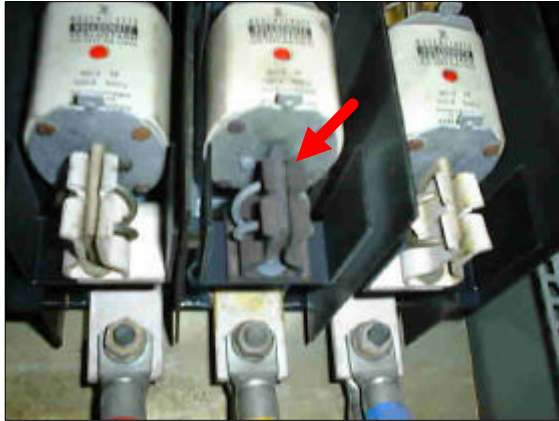
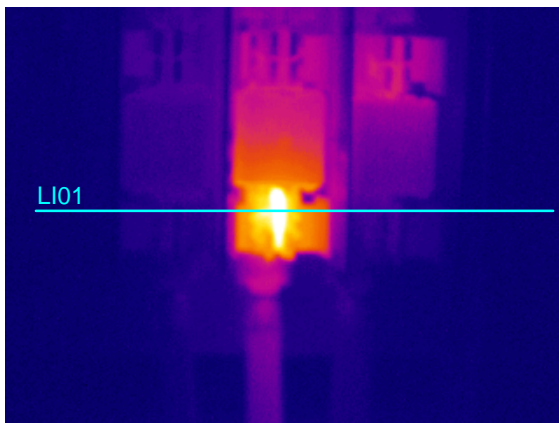
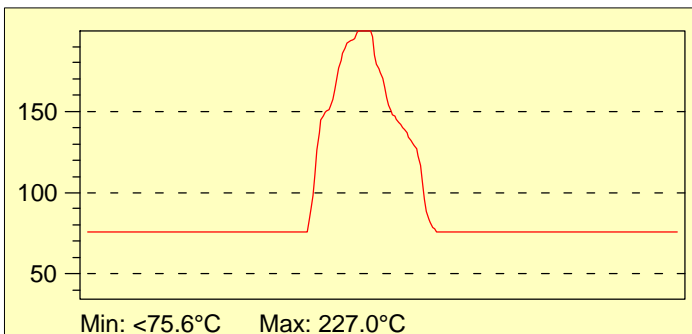
Fault	Bad connection
-------	----------------

Object parameter	Value
Emissivity	0.90
Object distance	1.5 m
Label	Value
LI01 : max	227.0°C

#### Replace

This item requires immediate attention, the corrosion is apparent on opening the panel. I would suggest replacing the swichfuse rather than attempting a repair. It would also be advisable to replace the cables on the bottom connection of the center phase

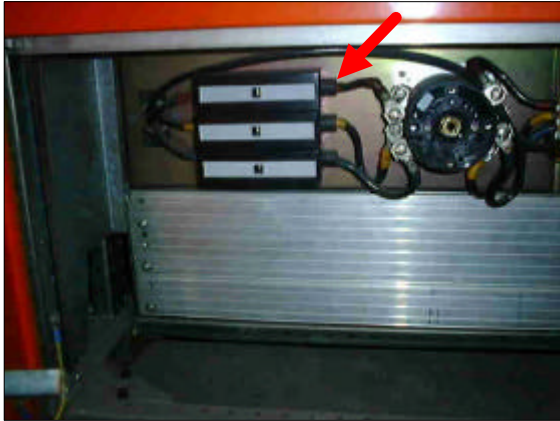
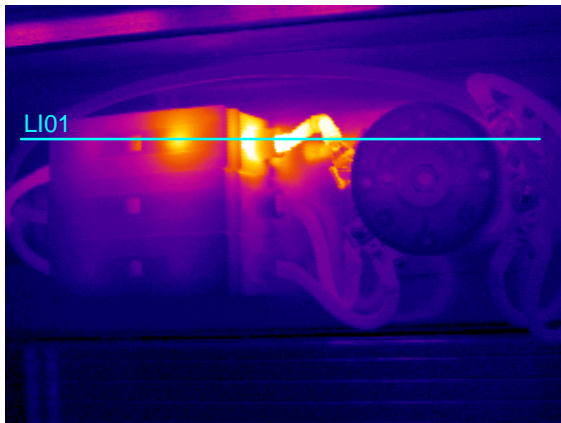
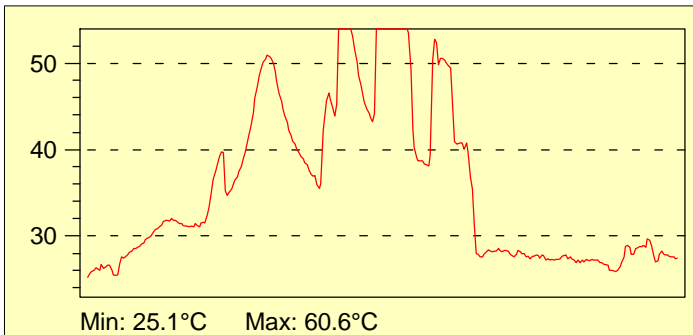
Fault	Bad Connection
-------	----------------

Object parameter	Value
Emissivity	0.89
Object distance	2.0 m
Label	Value
LI01 : max	60.6°C

### Repair

Check connections remake if necessary. Check condition of fuse, carrier and cap and replace if there are any signs of deterioration.

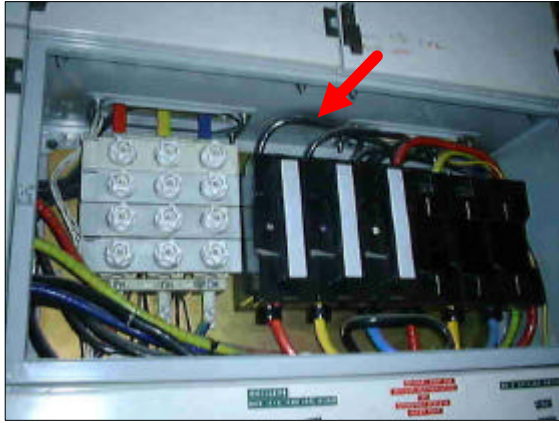
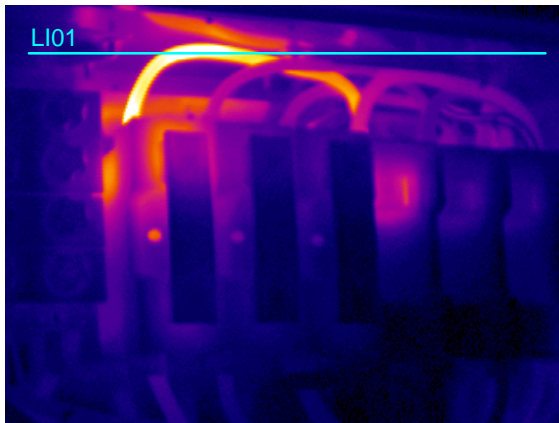
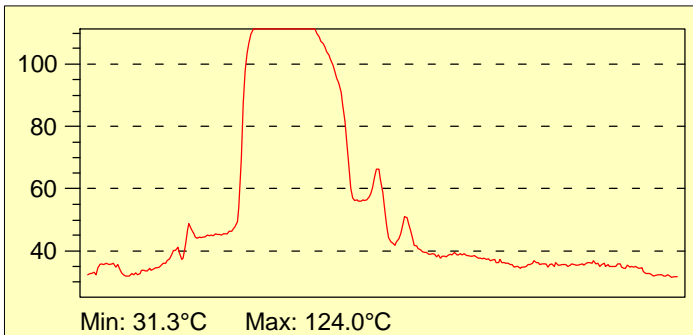
Fault	Bad Connection
-------	----------------

Object parameter	Value
Emissivity	0.89
Object distance	2.0 m
Label	Value
LI01 : max	124.0°C

### Repair or Replace

Check connections remake if necessary. Check condition of fuse, carrier and cap and replace if there are any signs of deterioration.

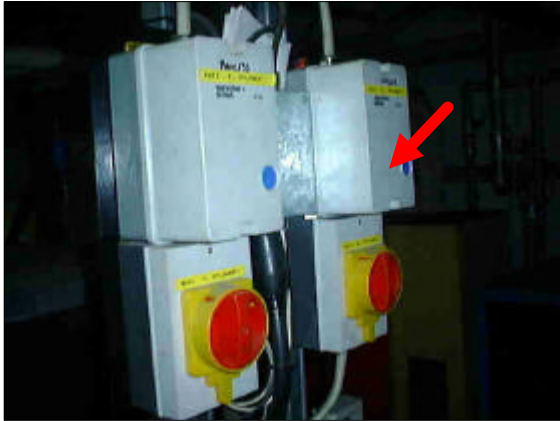
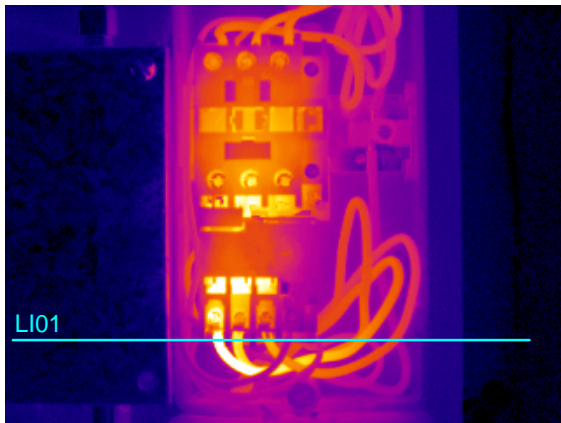
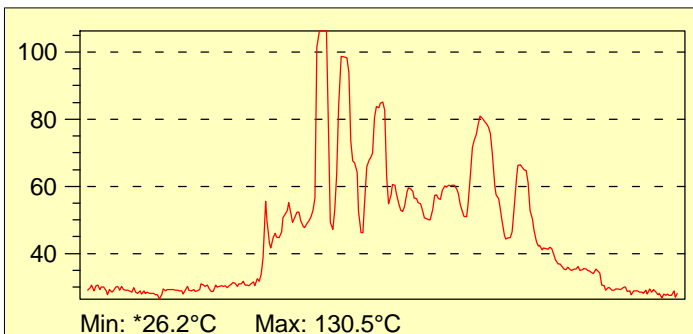
Fault	Overheating
-------	-------------

Object parameter	Value
Emissivity	0.86
Object distance	2.0 m
Label	Value
LI01 : max	130.5°C

### Repair or Replace

Check connections remake if necessary. Check condition of all components and replace if there are any signs of deterioration. Load testing all phases would also be recommended. If no explanation for the temperatures is found then this item should be replaced with a more suitable starter.
