Service Bulletin

AMERICAN HONDA MOTOR CO., INC.

2001 GL1800 Coolant Temperature Gauge Improvement

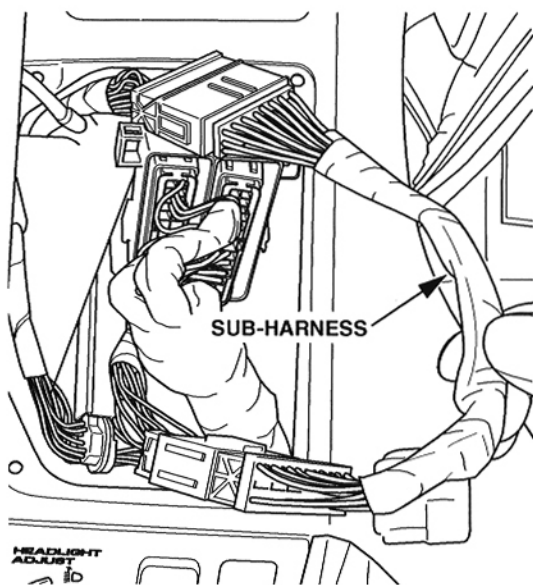
Do not allow the middle section of the sub-harness to bend, it will break.

7. Plug the new sub-harness inline with the BLUE connector. Route the wires to the side of the connector holder (toward the center of the bike).
