Service Bulletin

American Honda Motor Co., Inc.

2001-2004 GL1800/A Trunk Opener Unit

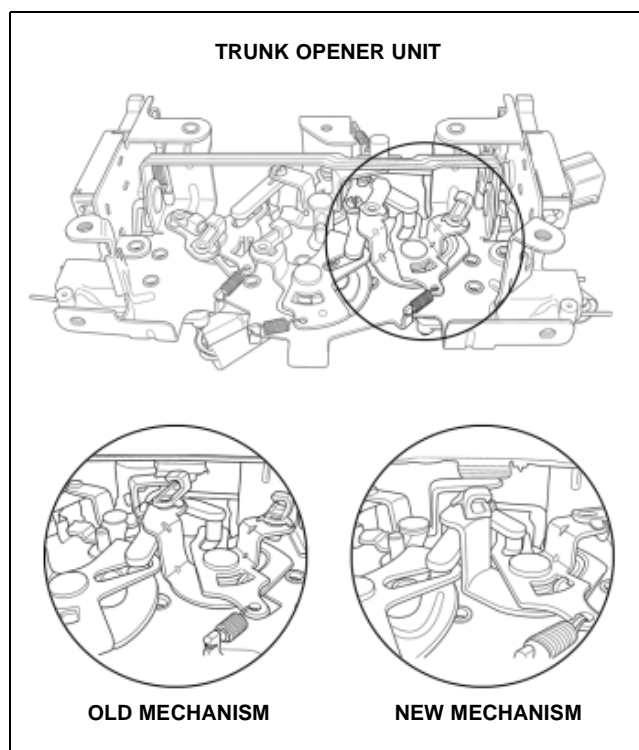
PART DESCRIPTION

Some customers may experience trunk or saddlebag lids not opening when the corresponding latch lever is pulled.

To correct this condition, the opener mechanism must be replaced with a new opener mechanism.

Opener Unit
P/N: 81310-MCA-A22
H/C: 7700768
